NAVY/MARINE CORPS HELICOPTER TAIL WIND TAKEOFF EVENTS

This short paper was initiated following a class A MV-22B mishap in Morocco that occurred during a tail wind take-off. All reportable tail wind events (Class A/B/C/D and Hazards) were included in the extracted data. The charts and tables that follow will show the Type/Model/Series of involved aircraft, the event location, event severity, relative wind, pilot at the controls flight hours and pilot at the controls causal factors. All data was extracted from the Web Enabled Safety System (WESS). Event dates span from 1 January 1980 to 24 July 2012.

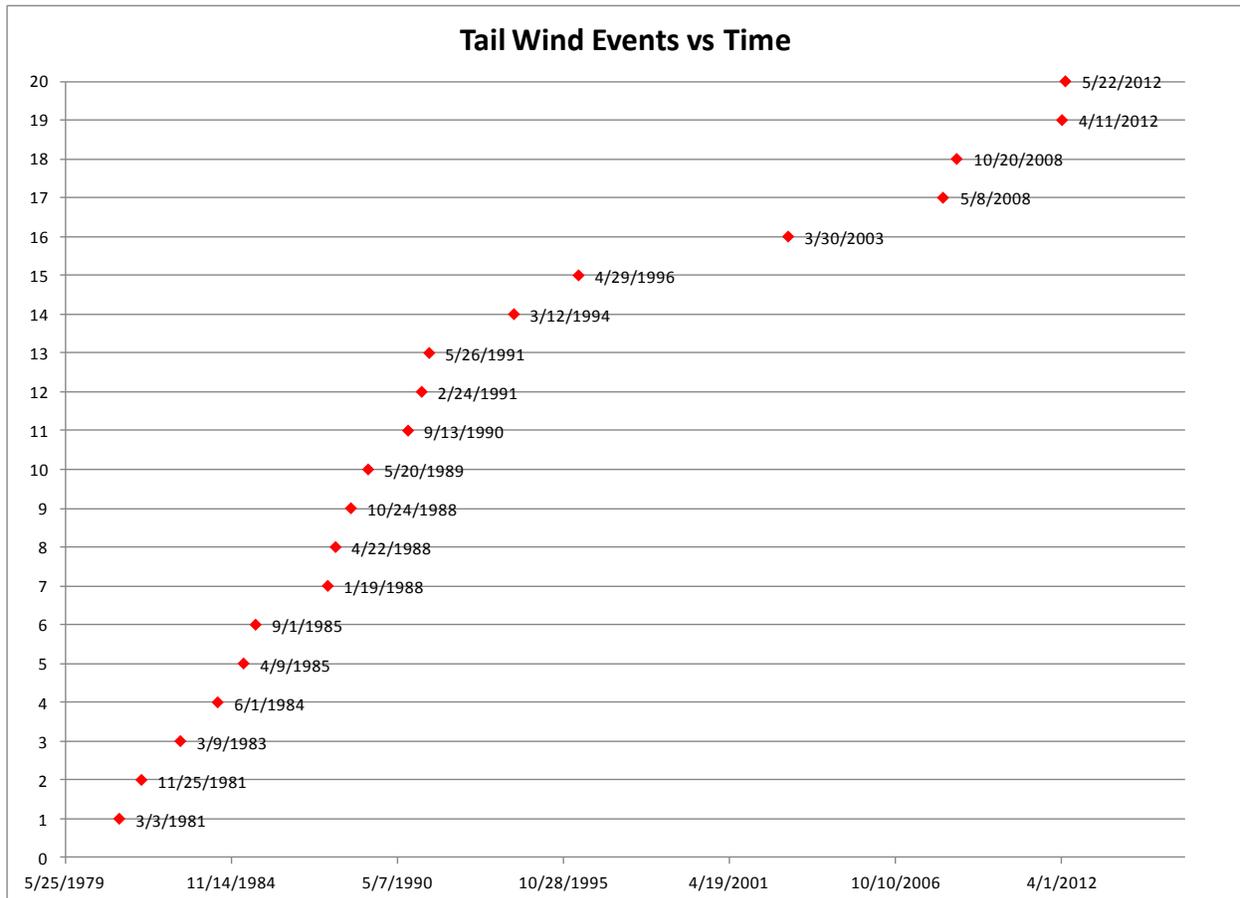
Fig 1: Tail Wind Event Frequency

It can be seen from figure 1 that the frequency of tail wind take-off events has decreased since 20 May 1989. The decreased slope of the line after that date indicates a

decreased frequency. A summary of the twenty events is displayed in figure 2.
