FLASH

actual Lines About submarine Hazards

October-December 2015 Edition

FLASH is a periodic release by the Afloat Safety Directorate of the Naval Safety Center. The information contained herein is a summary of research from selected reports of submarine hazards to assist the Submarine Force with mishap prevention programs. The FLASH is intended to give advanced coverage of safety-related information while reducing individual reading time. This bulletin does **not**, in itself, constitute authority but will cite authoritative references when available. **It is recommended that this newsletter be made available to All Hands.**

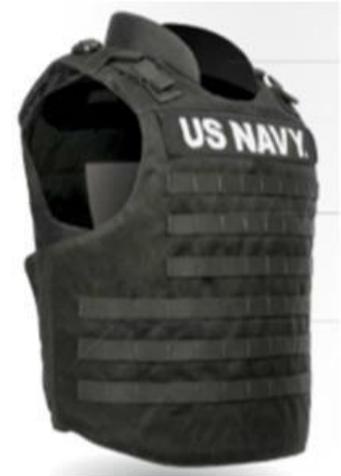
Naval Security Forces Vest (NSFV):

- Replaces CTRC and NFV
- Navy design for Navy threat environment
- Provides protection against LE, fragmentation threats
- Designed to operate with ESAPI for increased protection
- Government testing and QA
- Fielding completed May 2015
- Sustainment ongoing

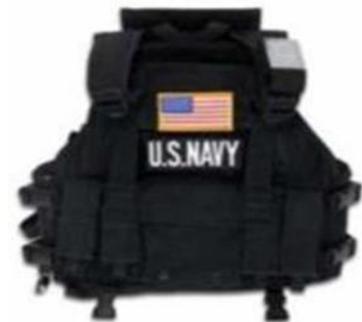
LBT-2564A VBSS Tactical Flotation Vest (TFV):

- Type V Personal Flotation Device
- Designed to operate with 10x12 torso and 5x7 side neutrally buoyant plates to provide ballistic protection
- Provides protection against NIJ Type III LE threats
- Sustainment ongoing via DLA

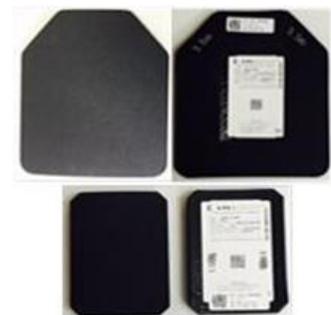
Neutrally Buoyant Ballistic Plate (NBBP):

- Replaces NIJ Type III
- Navy design for Navy threat environment
- Provides protection against LE, fragmentation threats
- Provides protection against Blunting Gap
